Technology Report 77-2

THE BROWNS FERRY NUCLEAR PLANT FIRE

ANDREW J. PRYOR
U.S. Energy Research
and Development Administration
Albuquerque, New Mexico

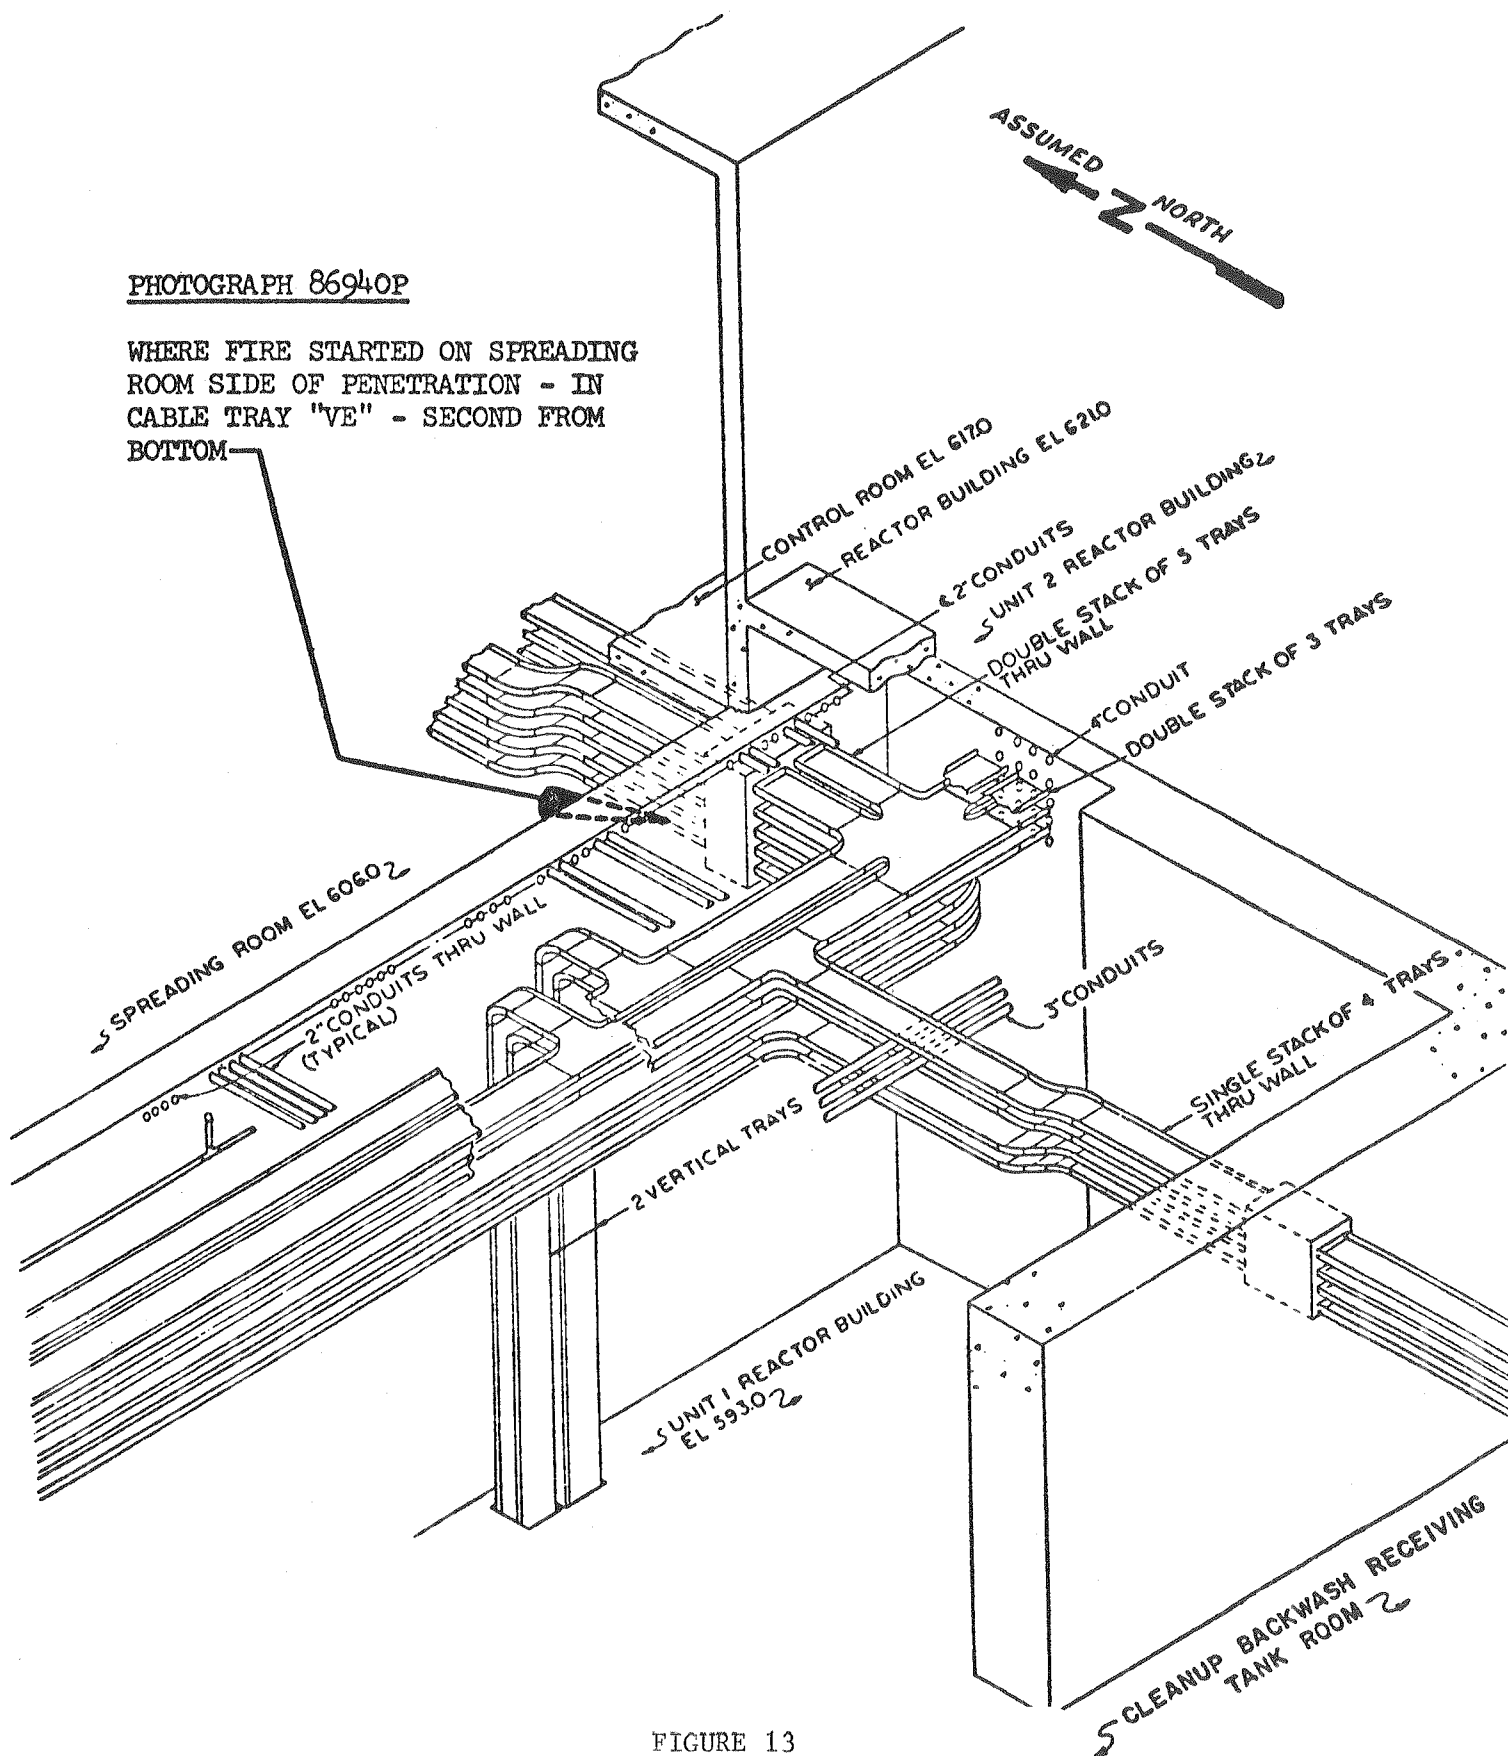
FIGURE 13
LOCATION WHERE PHOTOGRAPH 86940P WAS
TAKEN

PHOTOGRAPH 86940P

WHERE FIRE STARTED ON SPREADING
ROOM SIDE OF PENETRATION - IN
CABLE TRAY "VE" - SECOND FROM
BOTTOM

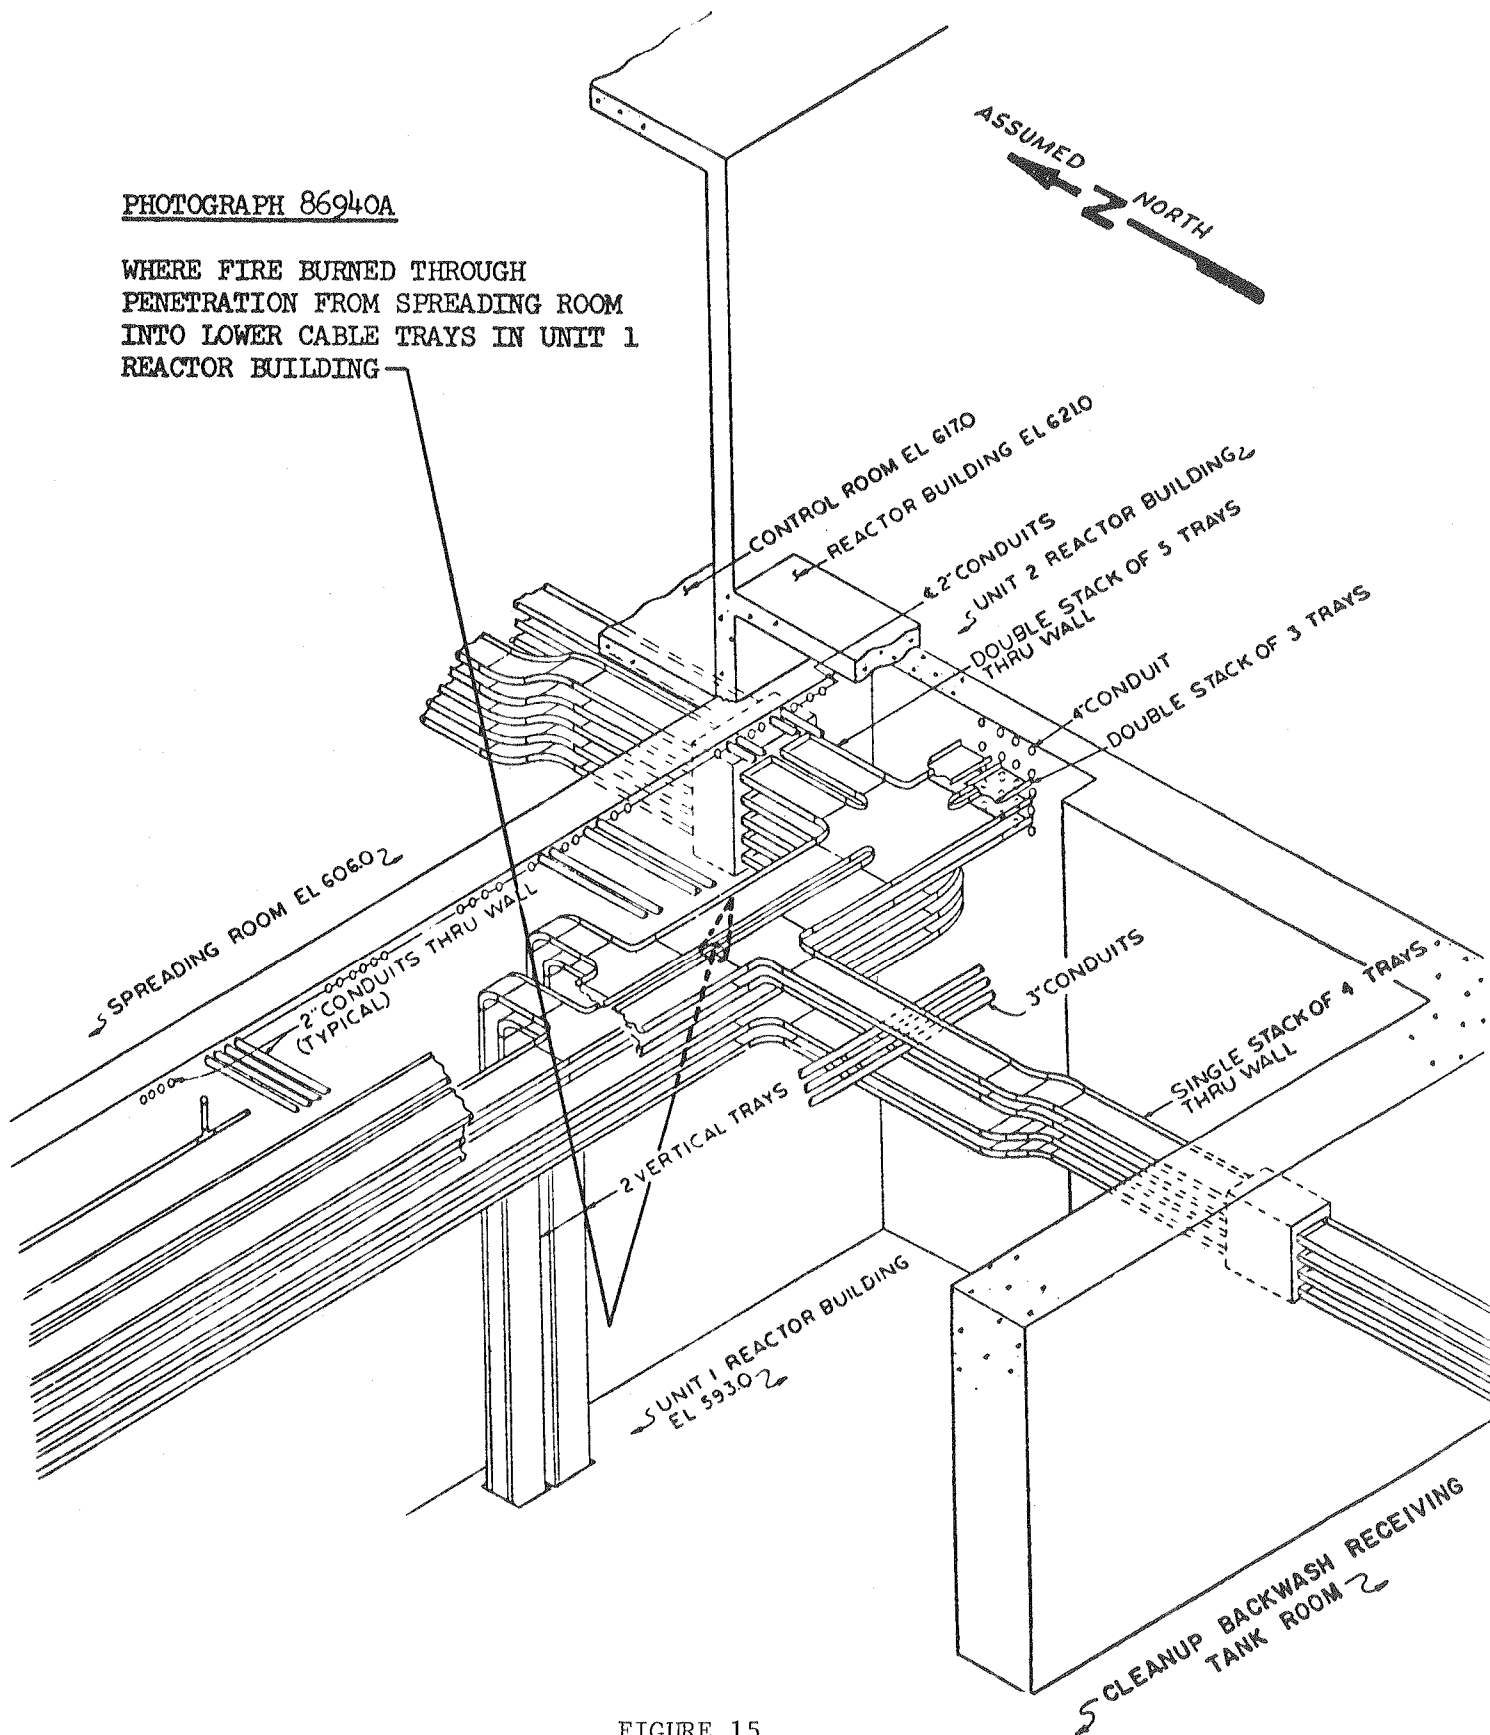
FIGURE 15
LOCATION WHERE PHOTOGRAPH 86940A WAS
TAKEN

PHOTOGRAPH 86940A

WHERE FIRE BURNED THROUGH
PENETRATION FROM SPREADING ROOM
INTO LOWER CABLE TRAYS IN UNIT 1
REACTOR BUILDING

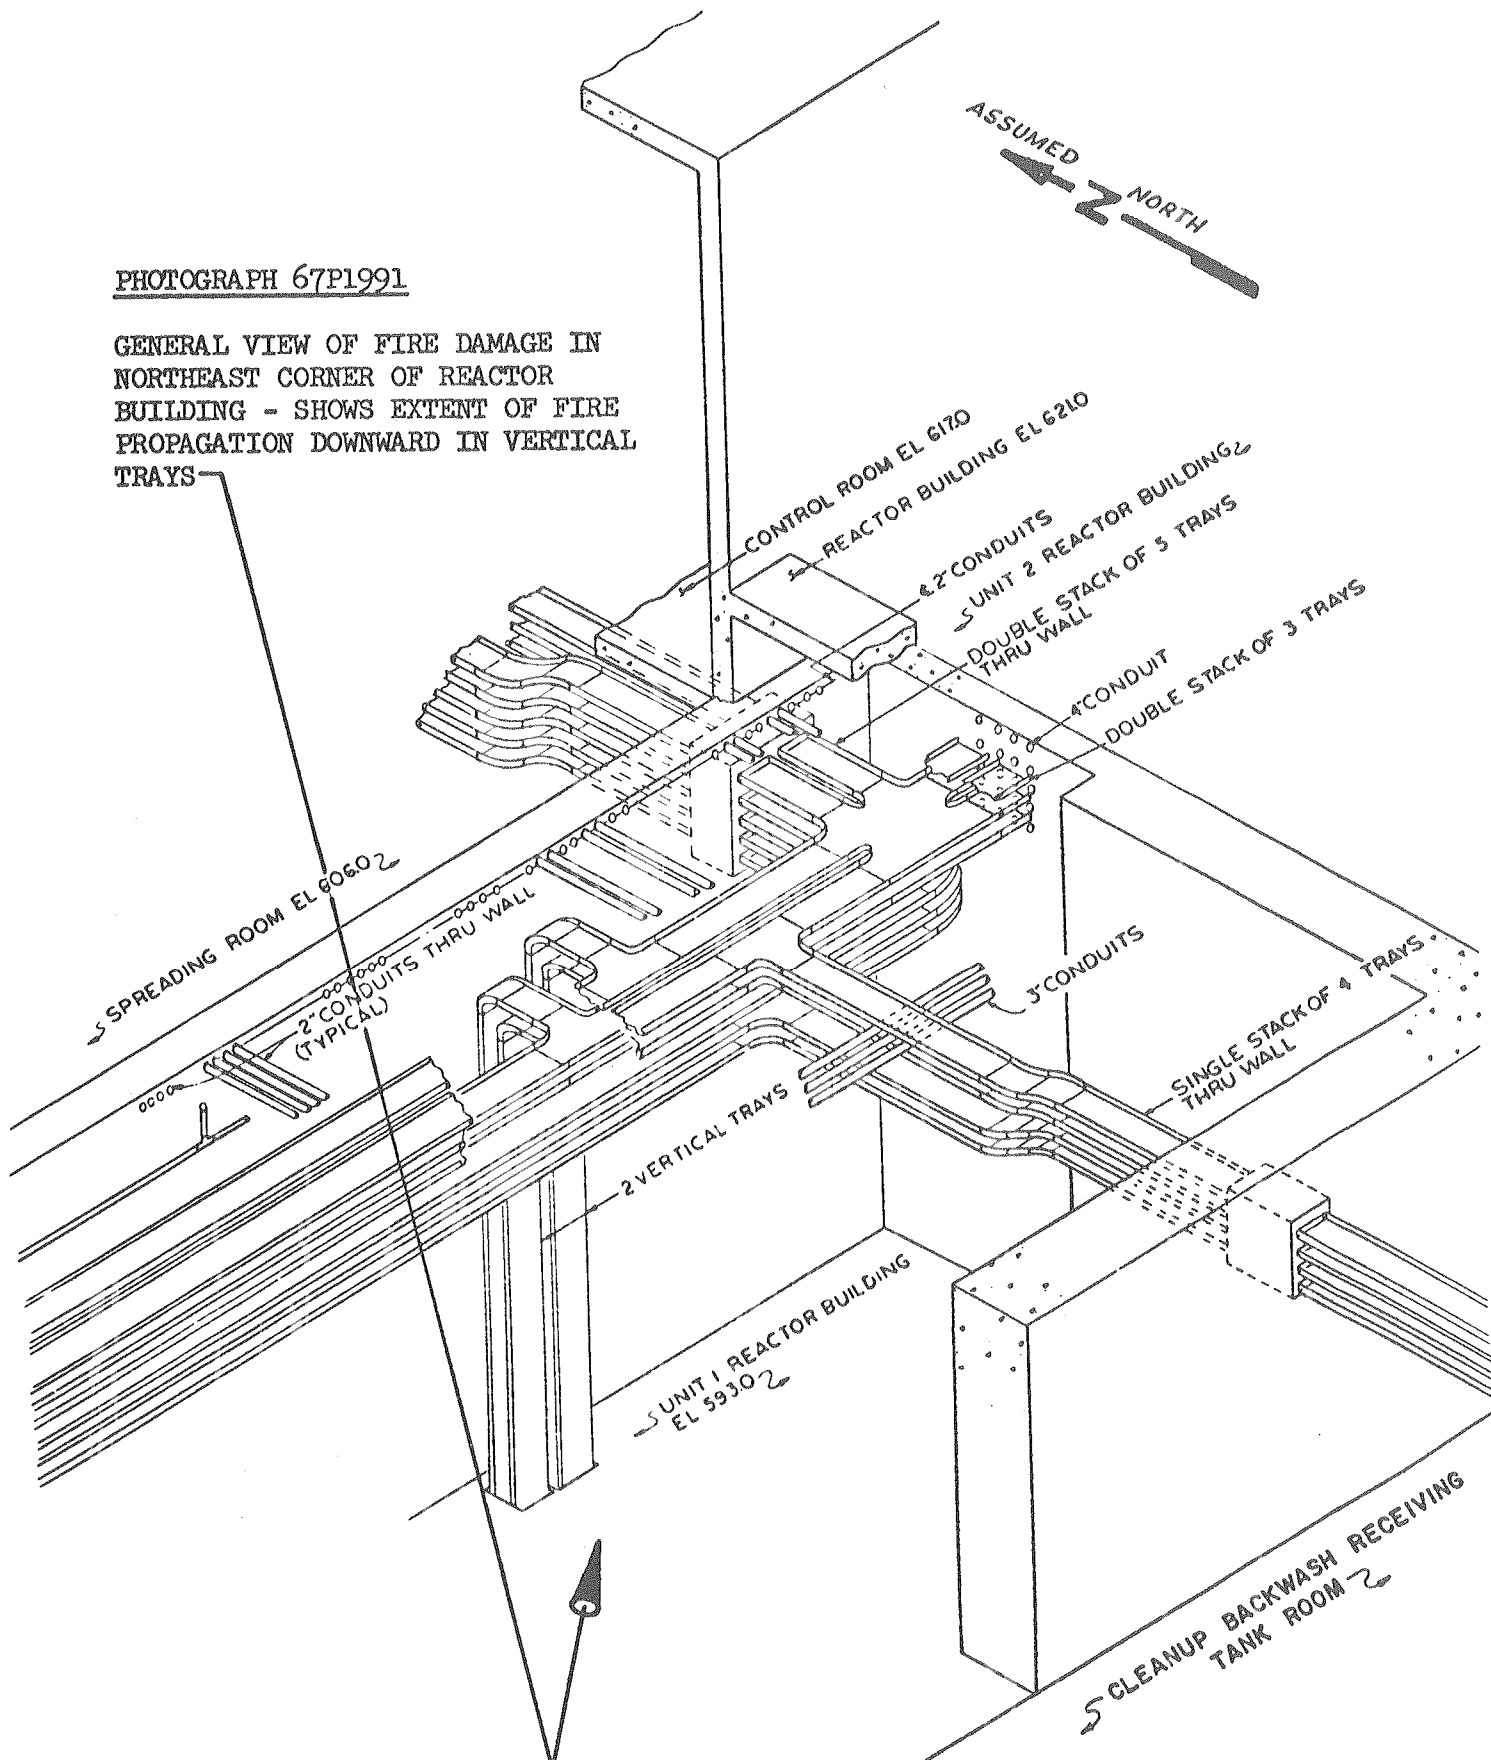
FIGURE 17
LOCATION WHERE PHOTOGRAPH 67P1991 WAS
TAKEN

PHOTOGRAPH 67P1991

GENERAL VIEW OF FIRE DAMAGE IN
NORTHEAST CORNER OF REACTOR
BUILDING - SHOWS EXTENT OF FIRE
PROPAGATION DOWNWARD IN VERTICAL
TRAYS

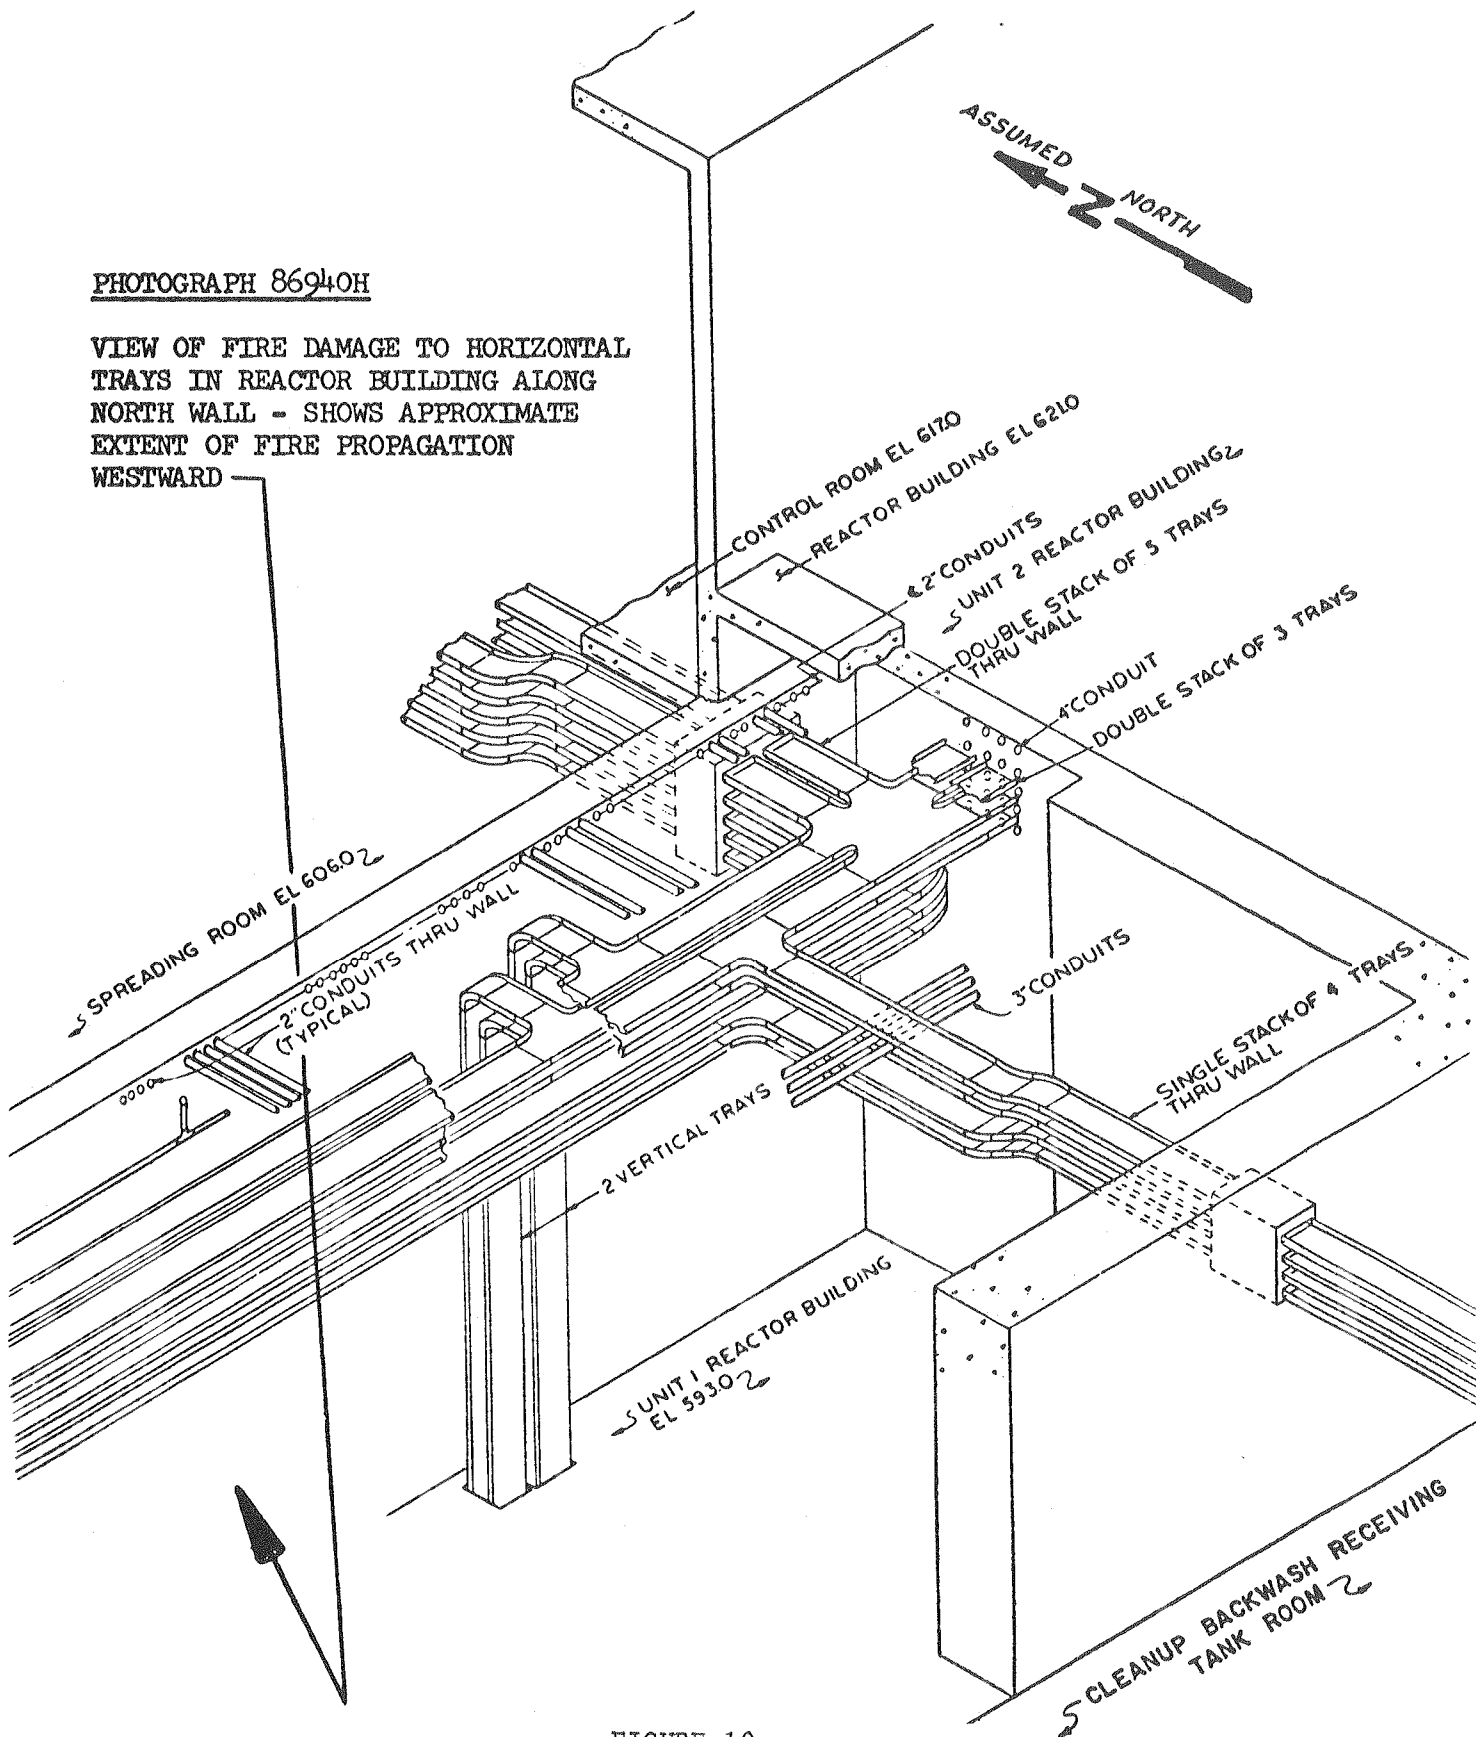
LOCATION WHERE PHOTOGRAPH 86940H WAS
TAKEN

PHOTOGRAPH 86940H

VIEW OF FIRE DAMAGE TO HORIZONTAL
TRAYS IN REACTOR BUILDING ALONG
NORTH WALL - SHOWS APPROXIMATE
EXTENT OF FIRE PROPAGATION
WESTWARD

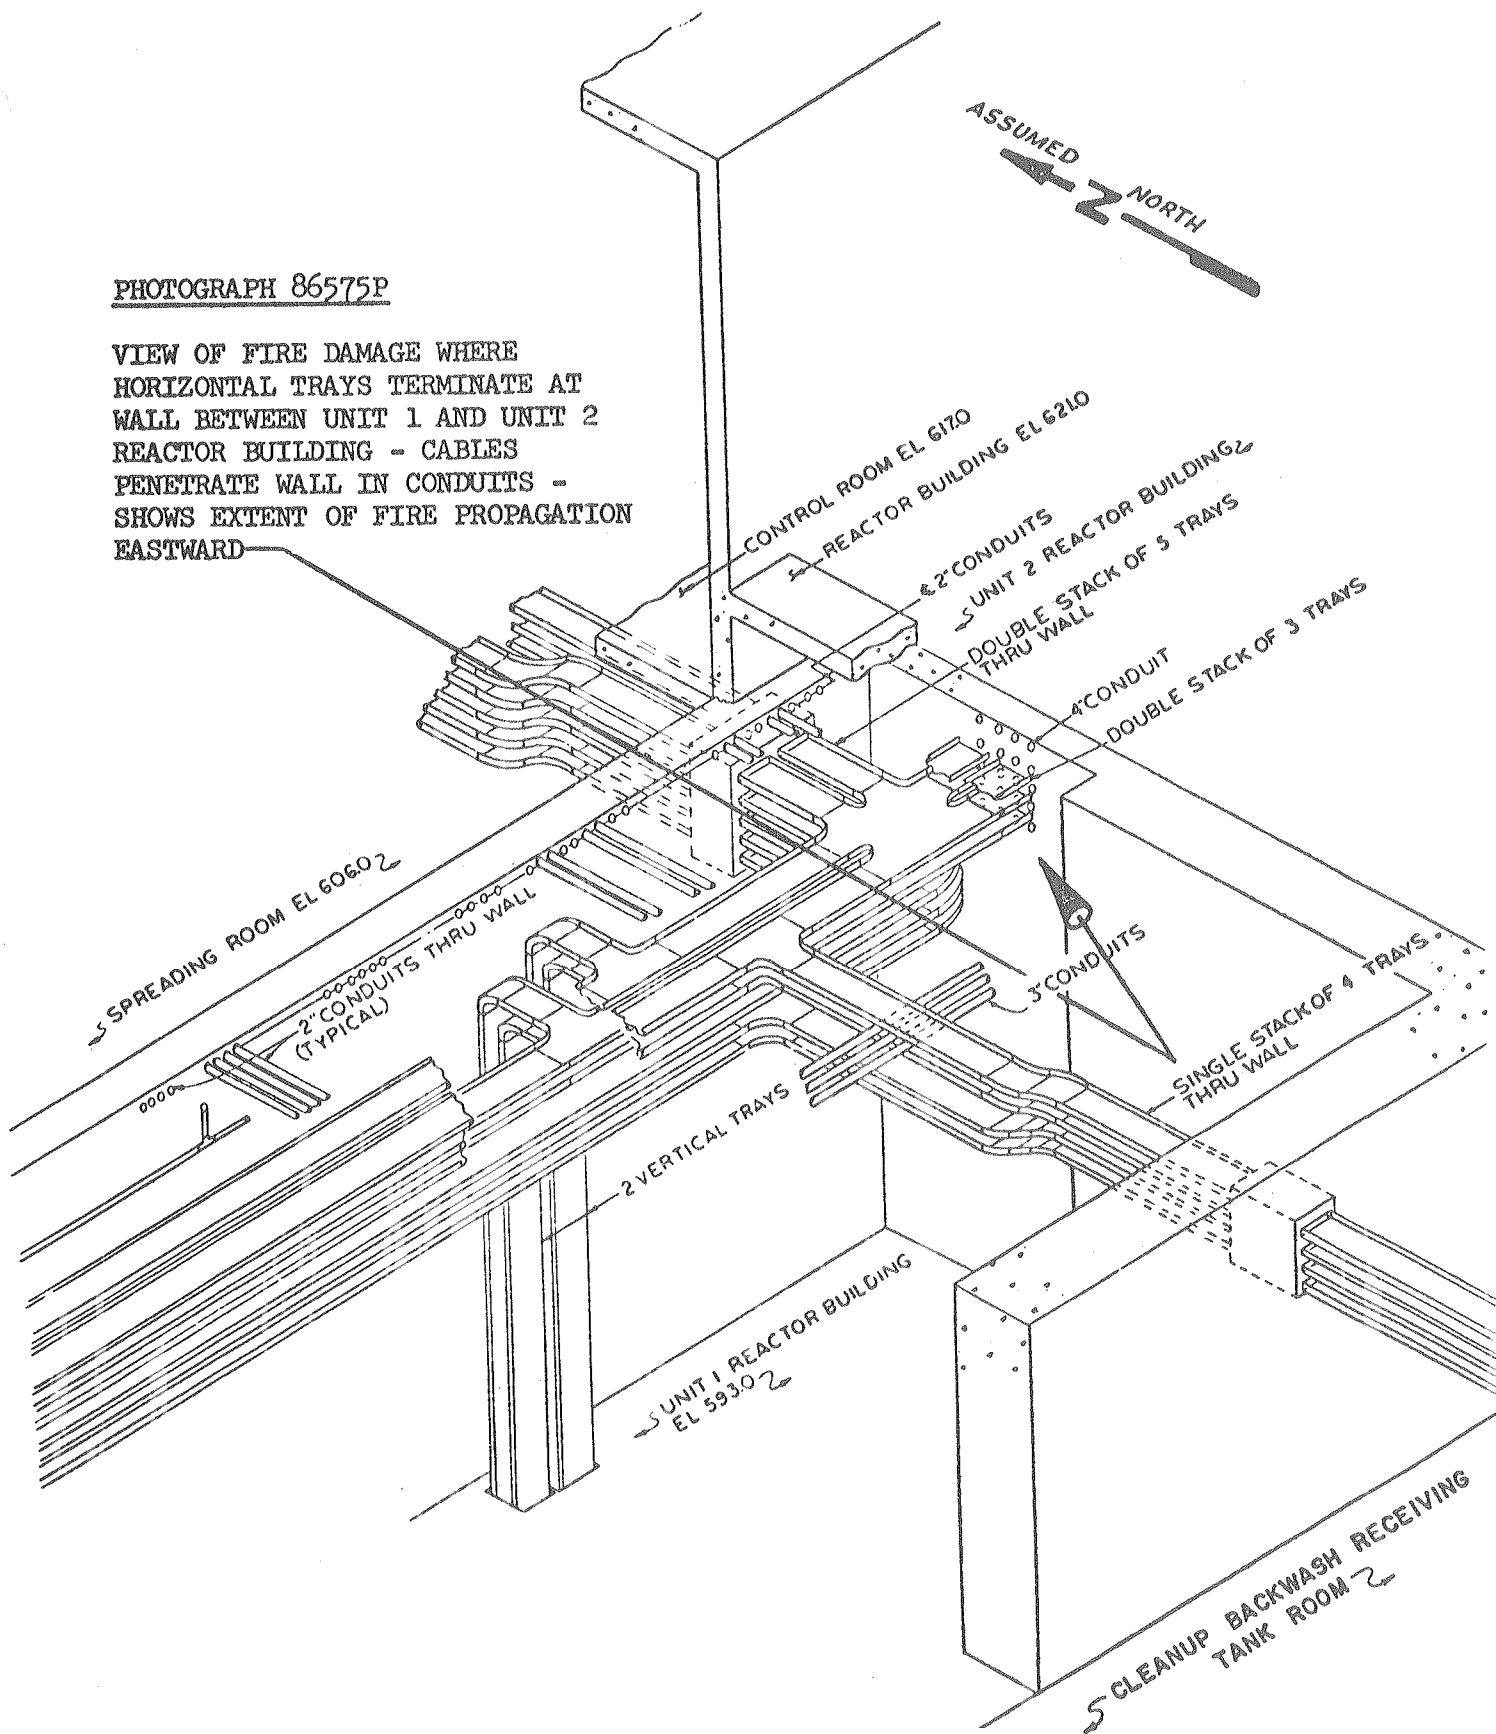
- FIGURE 21 LOCATION WHERE PHOTOGRAPH 86575P WAS TAKEN
- FIGURE 22 FIRE DAMAGE WHERE HORIZONTAL TRAYS TERMINATE AT WALL BETWEEN UNIT 1 AND 2 REACTOR BUILDING - CABLES PENETRATE WALL IN CONDUITS - SHOWS EXTENT UNIT OF FIRE PROPAGATION EASTWARD

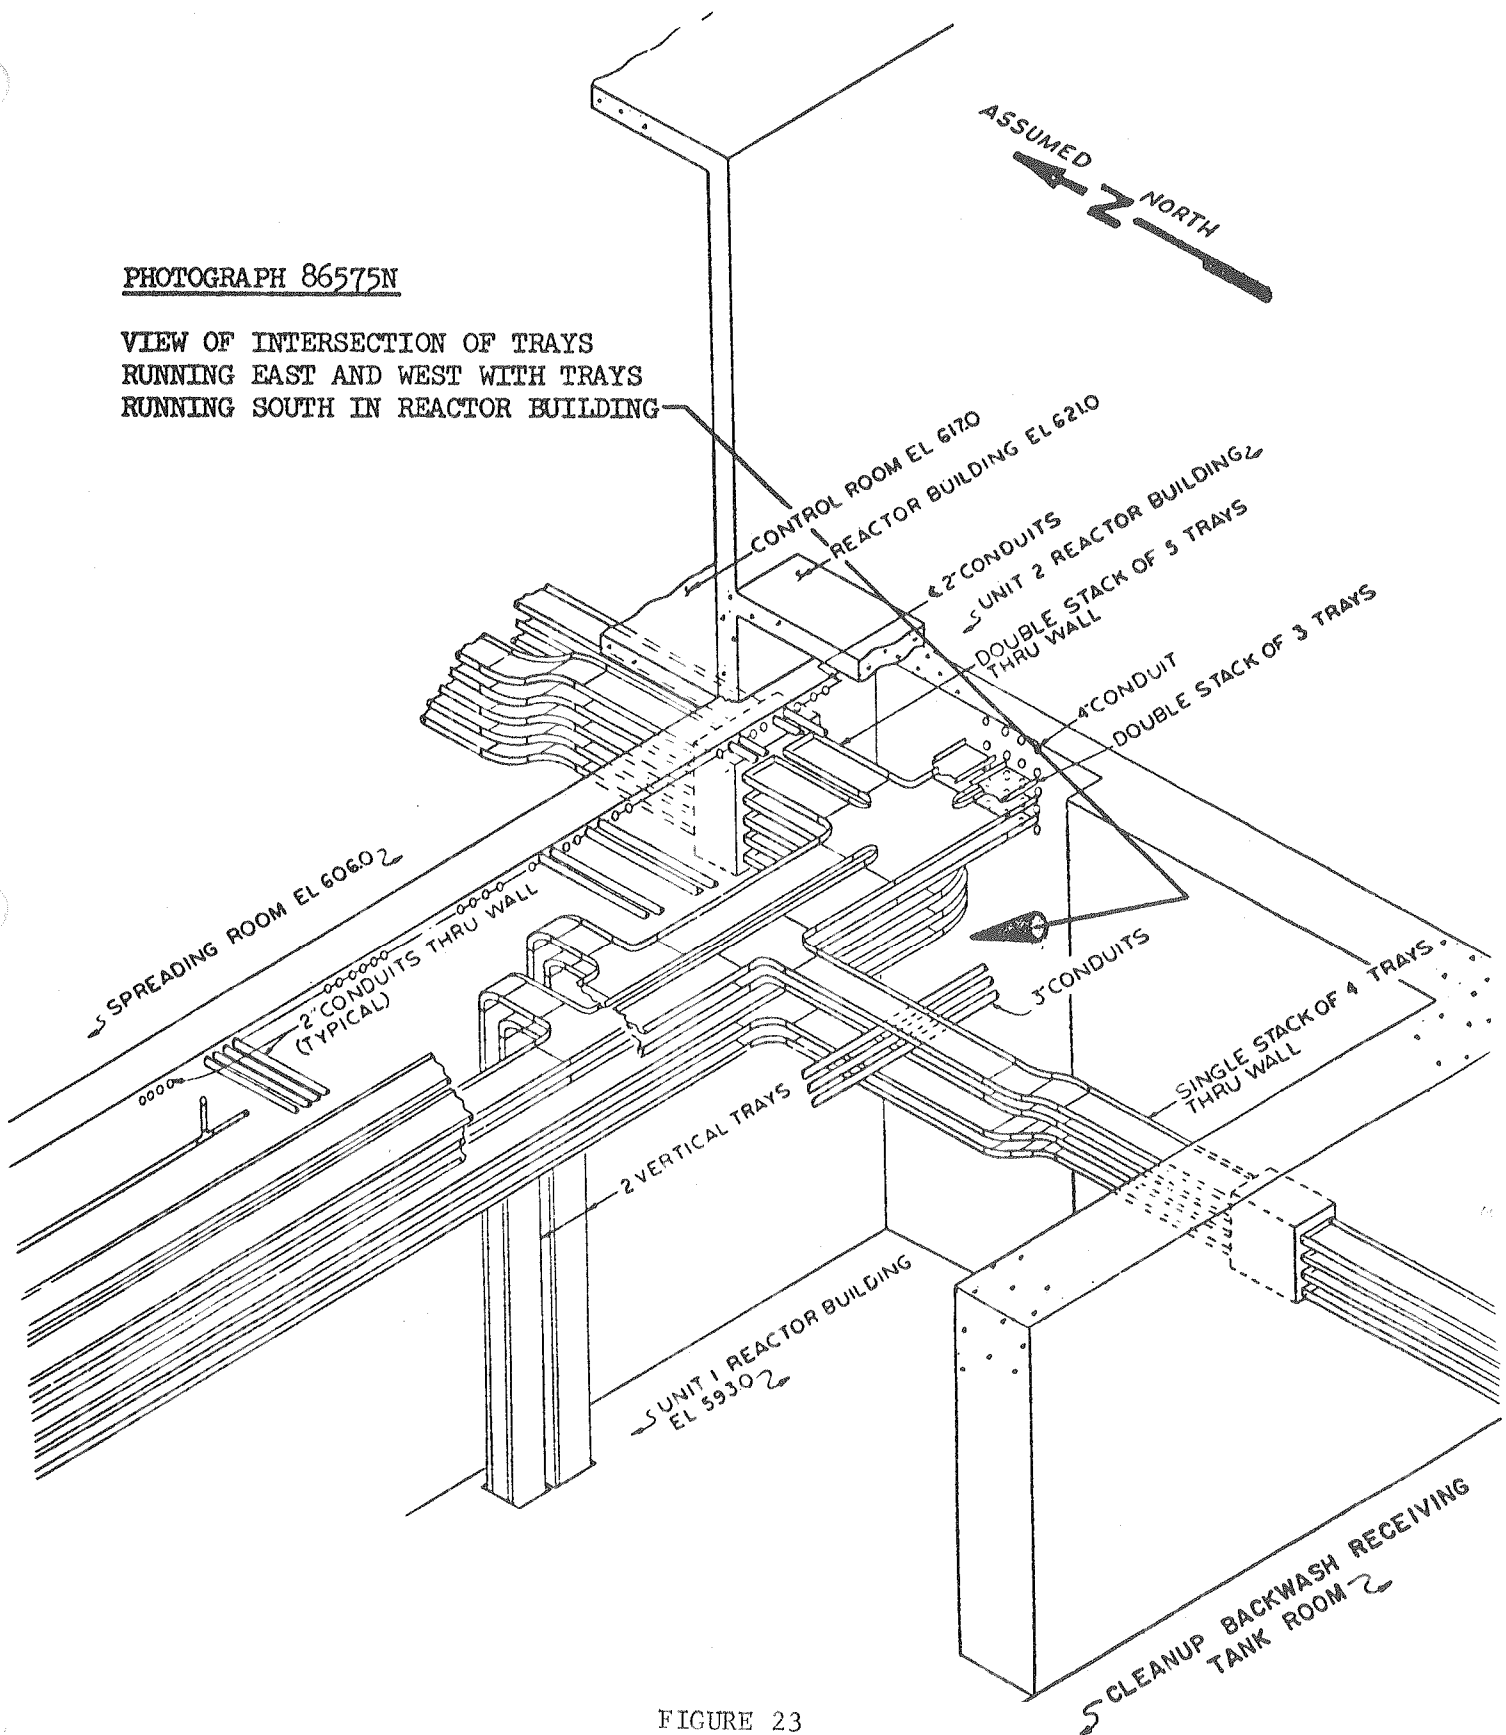
FIGURE 23
LOCATION WHERE PHOTOGRAPH 86575N WAS
TAKEN

PHOTOGRAPH 86575N

VIEW OF INTERSECTION OF TRAYS
RUNNING EAST AND WEST WITH TRAYS
RUNNING SOUTH IN REACTOR BUILDING

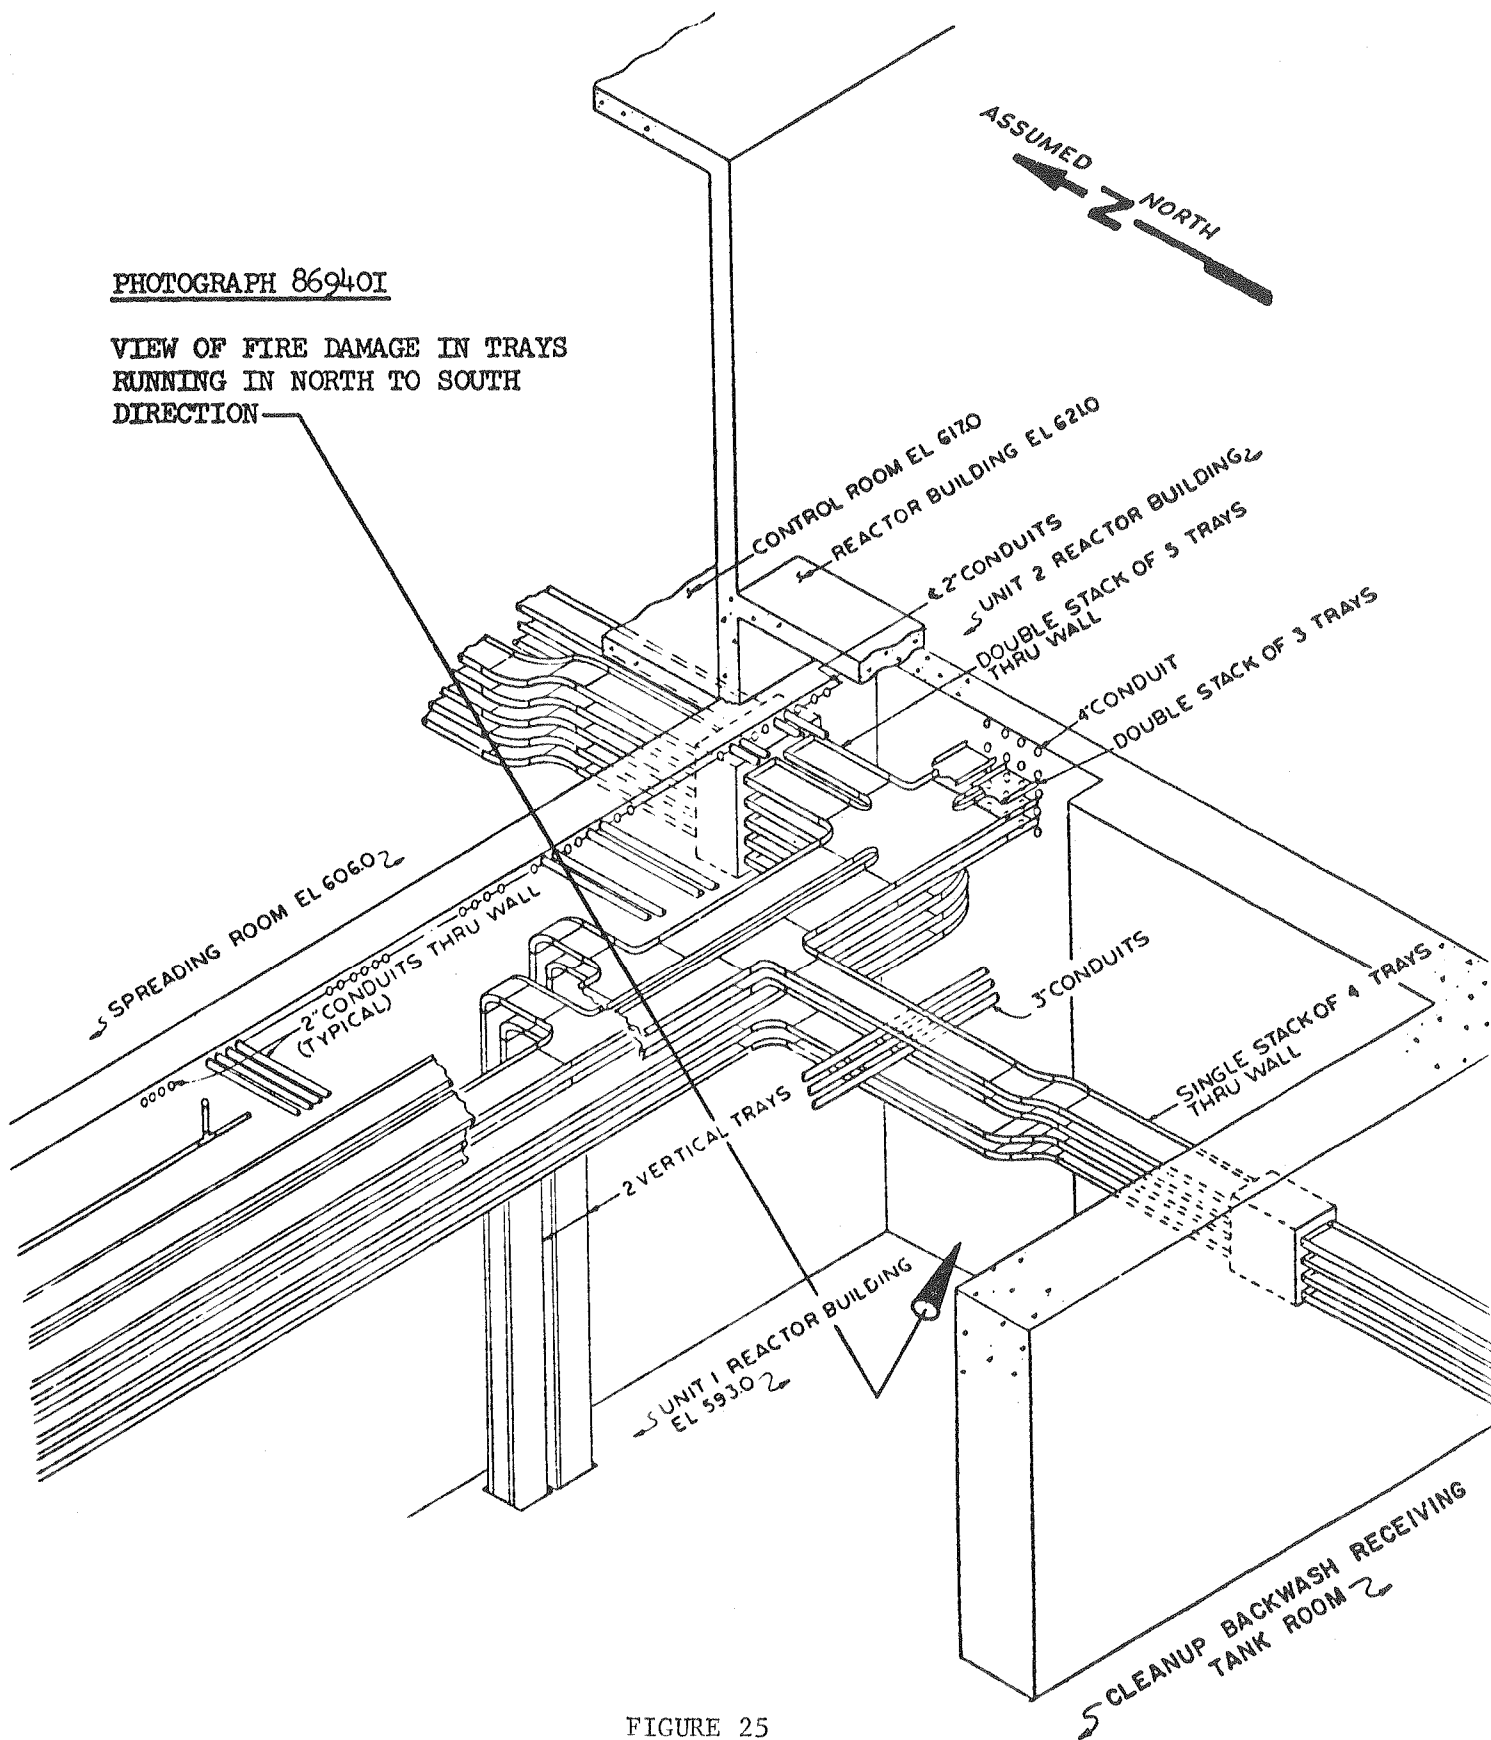
FIGURE 25
LOCATION WHERE PHOTOGRAPH 86940I WAS
TAKEN

FIGURE 26
FIRE DAMAGE IN TRAYS RUNNING IN NORTH
TO SOUTH DIRECTION

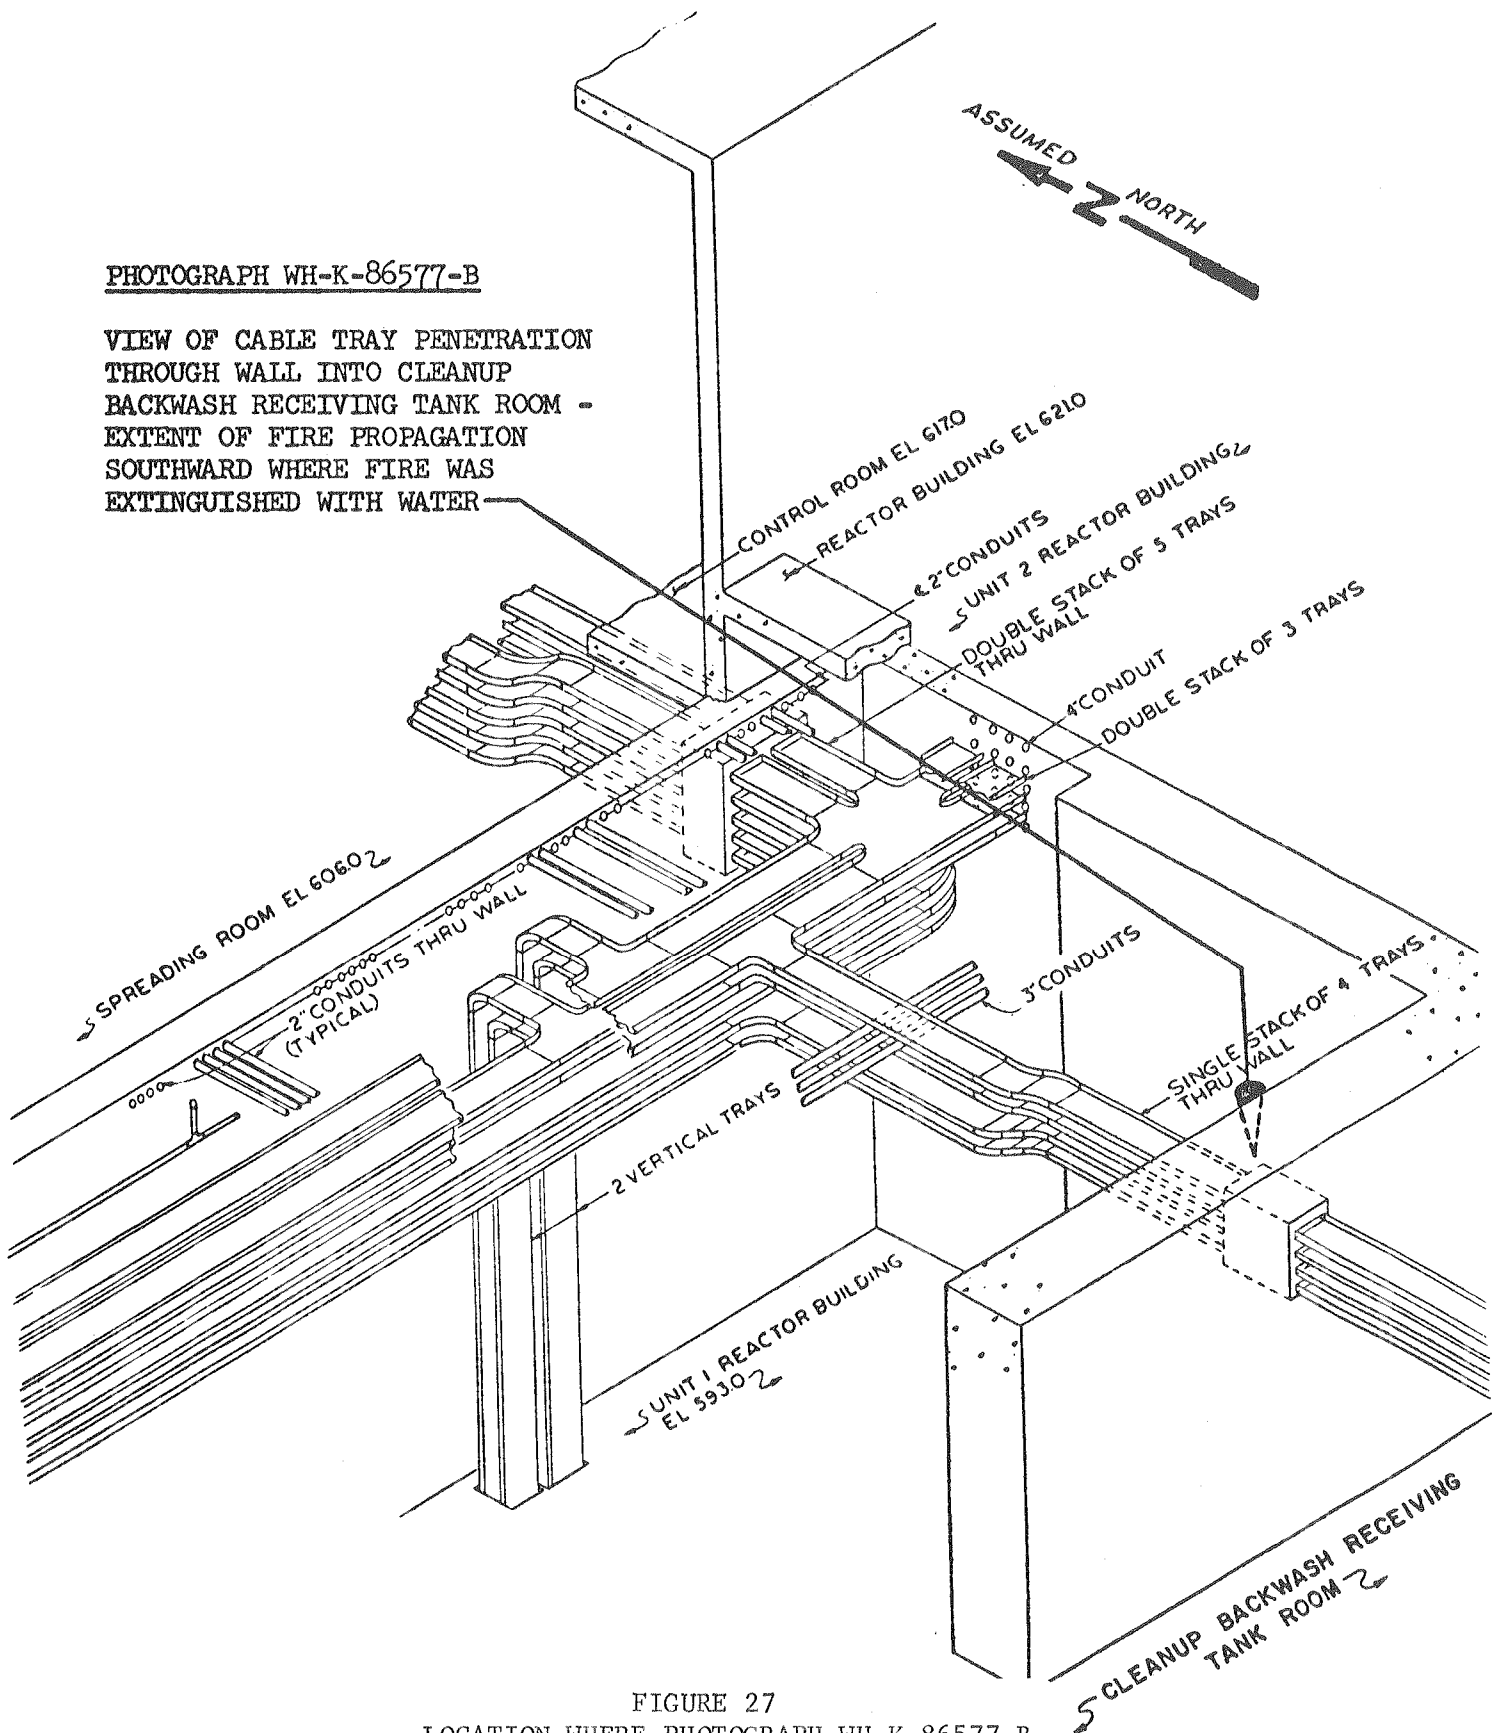
FIGURE 27
LOCATION WHERE PHOTOGRAPH WH-K-86577-B
WAS TAKEN

PHOTOGRAPH WH-K-86577-B

VIEW OF CABLE TRAY PENETRATION
THROUGH WALL INTO CLEANUP
BACKWASH RECEIVING TANK ROOM -
EXTENT OF FIRE PROPAGATION
SOUTHWARD WHERE FIRE WAS
EXTINGUISHED WITH WATER
